Bass Lake Tributary Study

August 22nd, 2024

Tip of the Mitt Watershed Council

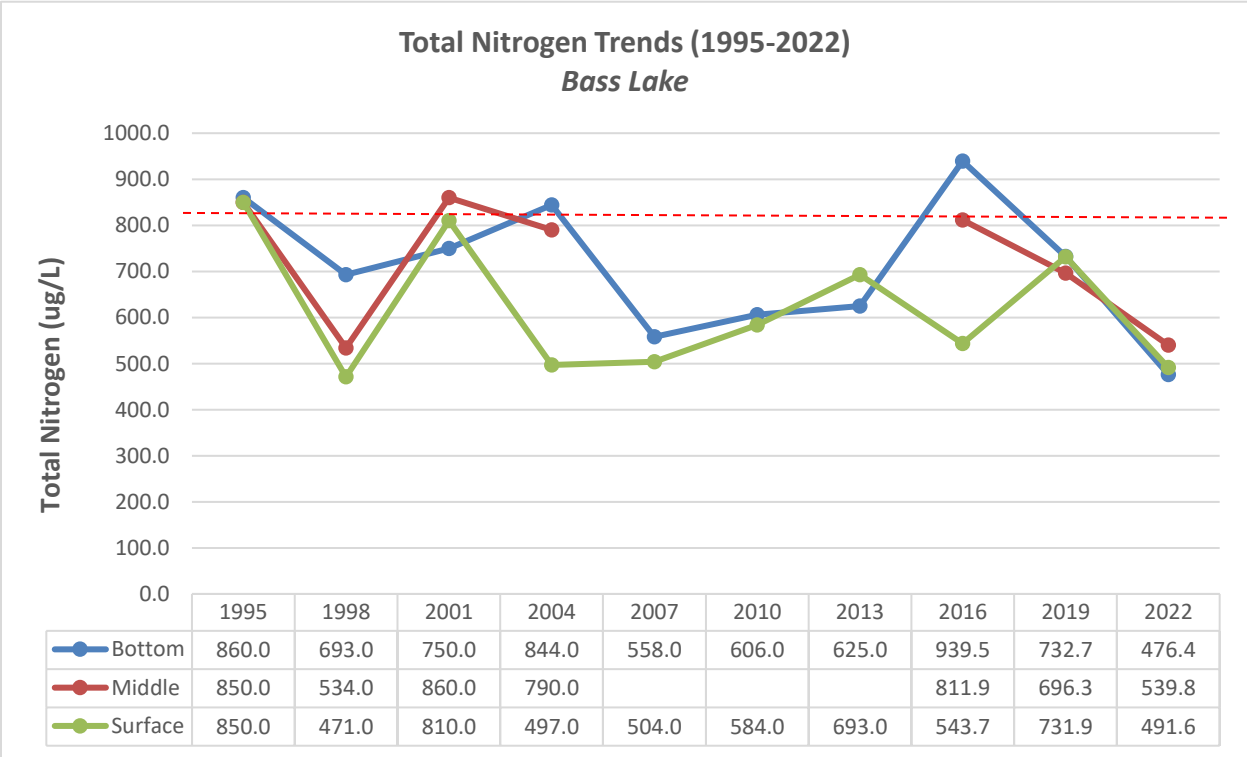
Figure 3. Nitrogen trends in Bass Lake from 1995-2022, collected through the Comprehensive Water Quality Monitoring Program. Note: Red dashed line indicates EPA recommended maximum value (810 ug/L).

Based on the above nutrient data, we see that phosphorus levels in Bass Lake did not follow a concrete trend during the years of data collection. Levels slightly breached the EPA recommended maximum in 2019, going above 20 ug/L (Figure 2). Nitrogen levels in Bass Lake did not exhibit a concrete trend. Levels breached the recommended maximum of 810 ug/L periodically throughout the years, but levels were only notably higher around 2016 (Figure 3). In relation to Secchi depths, water clarity was lowest around 1994, where eutrophic conditions were briefly observed (Secchi disc reading of about 7.5 feet, Figure 4). Chlorophyll-*a* concentrations exhibited no concrete trend throughout the years, but did not demonstrate eutrophic conditions (levels were all under 6.0 ug/L, Figure 5). Finally, trophic status index values for Bass Lake did not surpass the value associated with eutrophic conditions (TSI \geq 48), and no concrete trend was detectable (Figure 6).

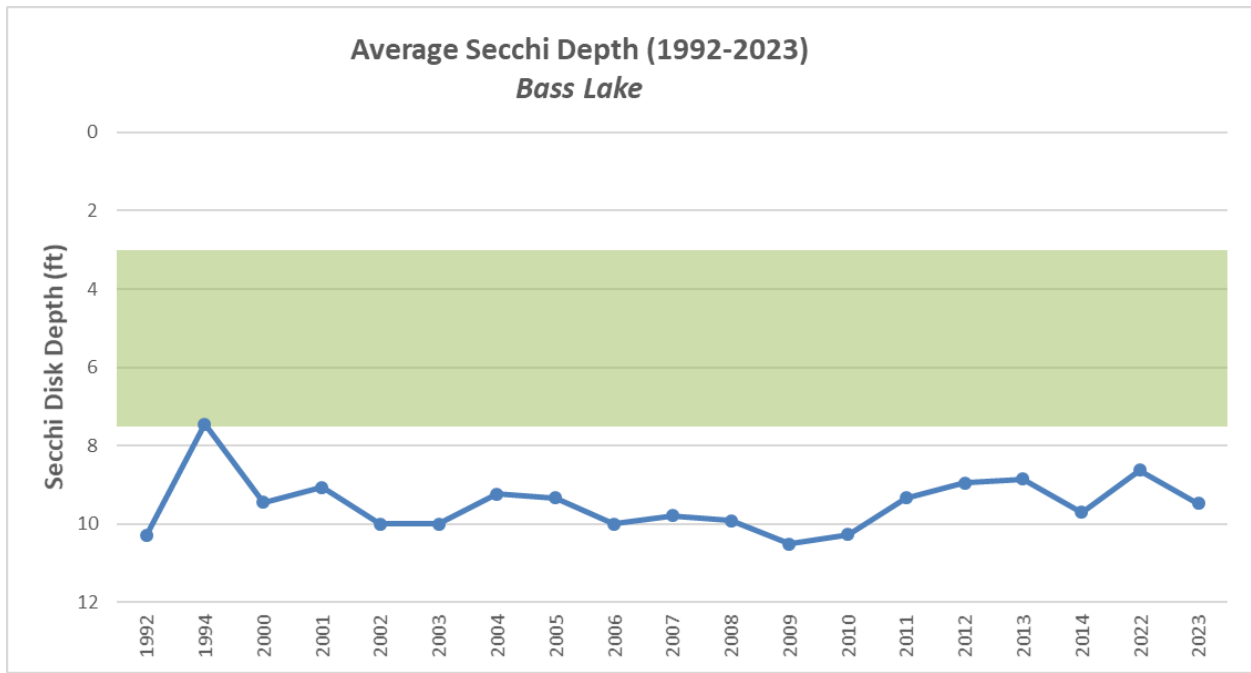
Figure 4. Secchi disk depth trends in Bass Lake from 1992-2023, collected through the Volunteer Lake Monitoring Program.

Note: Green shaded region indicates a eutrophic ecosystem (Secchi depth readings of 3.0 feet to 7.5 feet). Readings less than 3.0 feet are indicative of a hypereutrophic ecosystem.

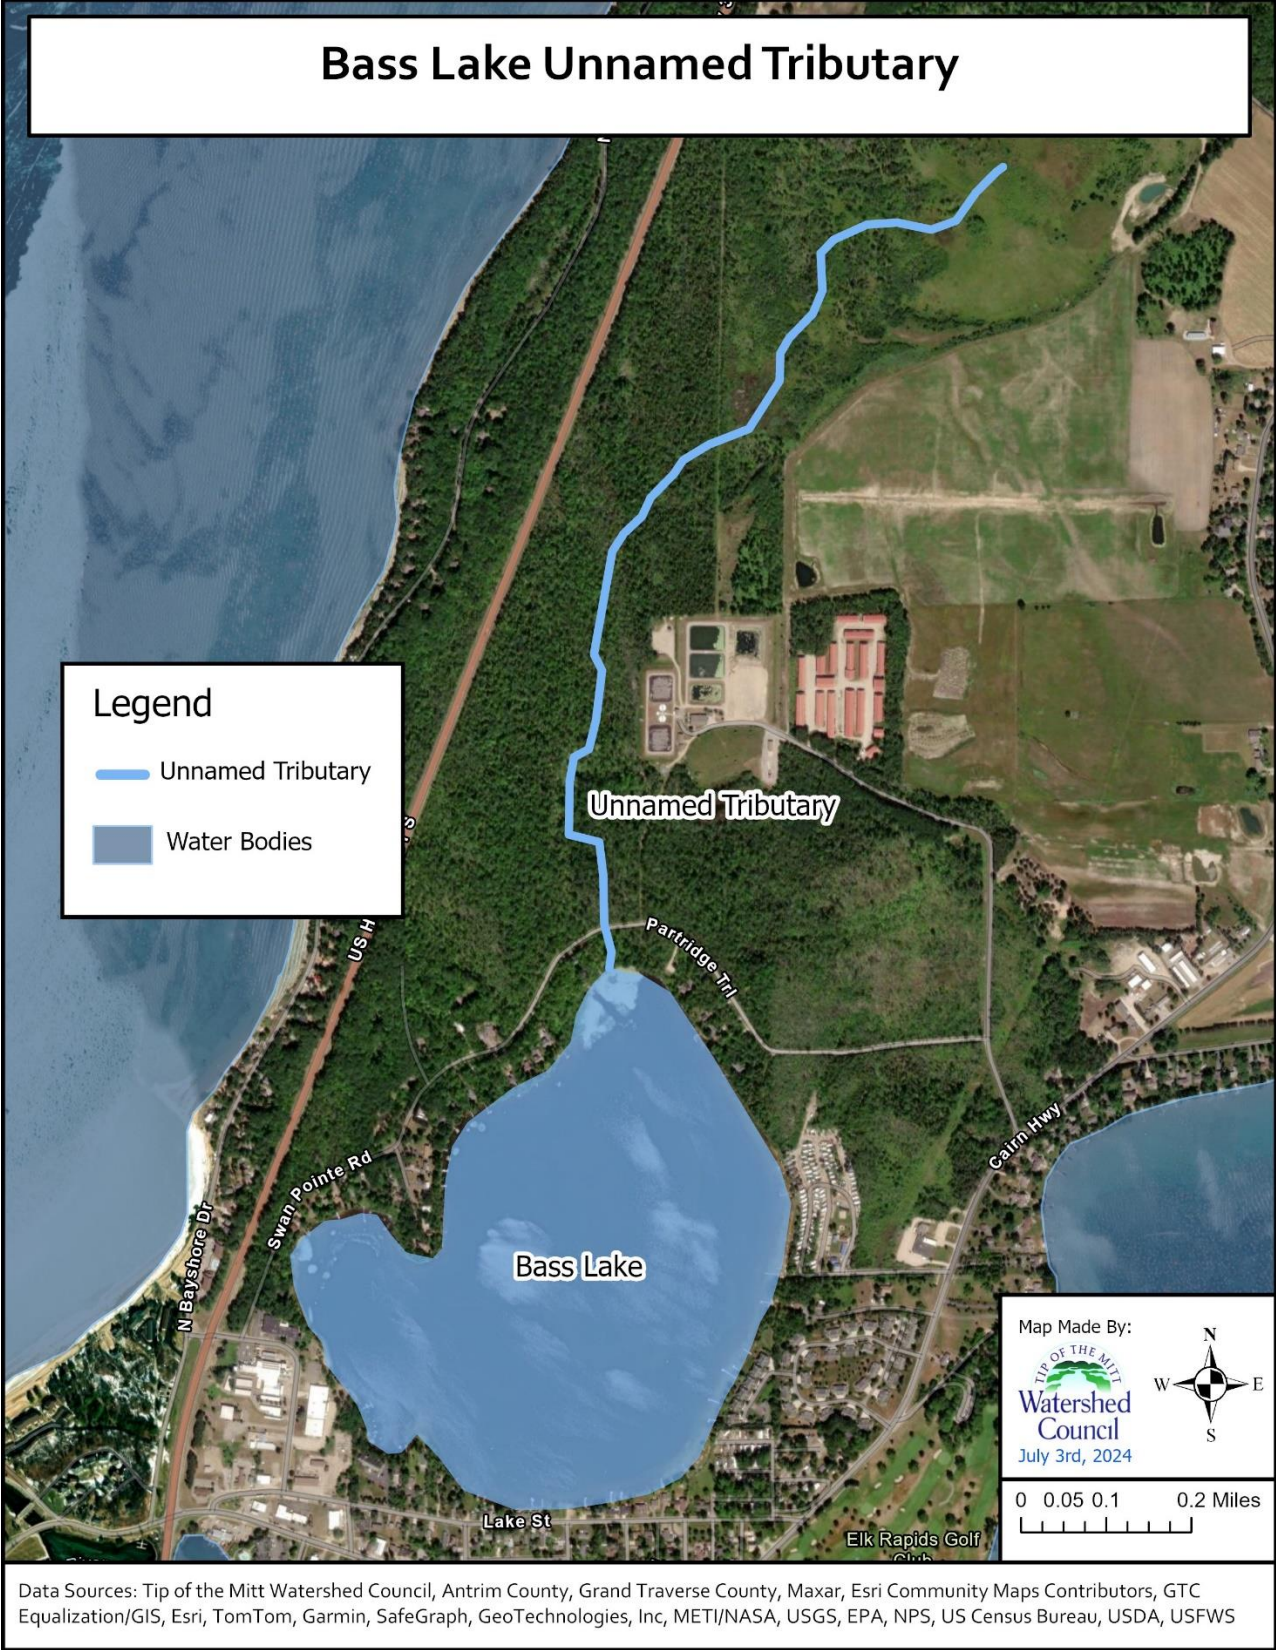
Figure 7. A map of Bass Lake and the unnamed tributary that was sampled for nutrients in accordance with the BLAER contract.

Bass Lake Association of Elk Rapids initially approached the Watershed Council with the suggestion of tributary monitoring based on their concerns regarding excess plant growth. As mentioned above, Bass Lake has had instances of both total phosphorus and total nitrogen exceedances throughout the course of CWQM monitoring. Total phosphorus levels in Bass Lake (middle and bottom-level samples) exceeded the recommended maximum in 2019 (reaching almost 25 ug/L), and total nitrogen levels in Bass Lake peaked in 2016, falling around 950 ug/L (exceedance of the maximum value of 810 ug/L). To further investigate potential sources of nutrient influx, and to rule out the single tributary as a source of nutrient pollution, BLAER pursued sampling the tributary for both total phosphorus and total nitrogen. Below is a map depicting the location of the Bass Lake tributary in relation to the lake and its surrounding watershed (Figure 7).
