Paradise Lake Association: Lake Quality and Best Practices Survey

September 1st, 2024

Tip of the Mitt Watershed Council

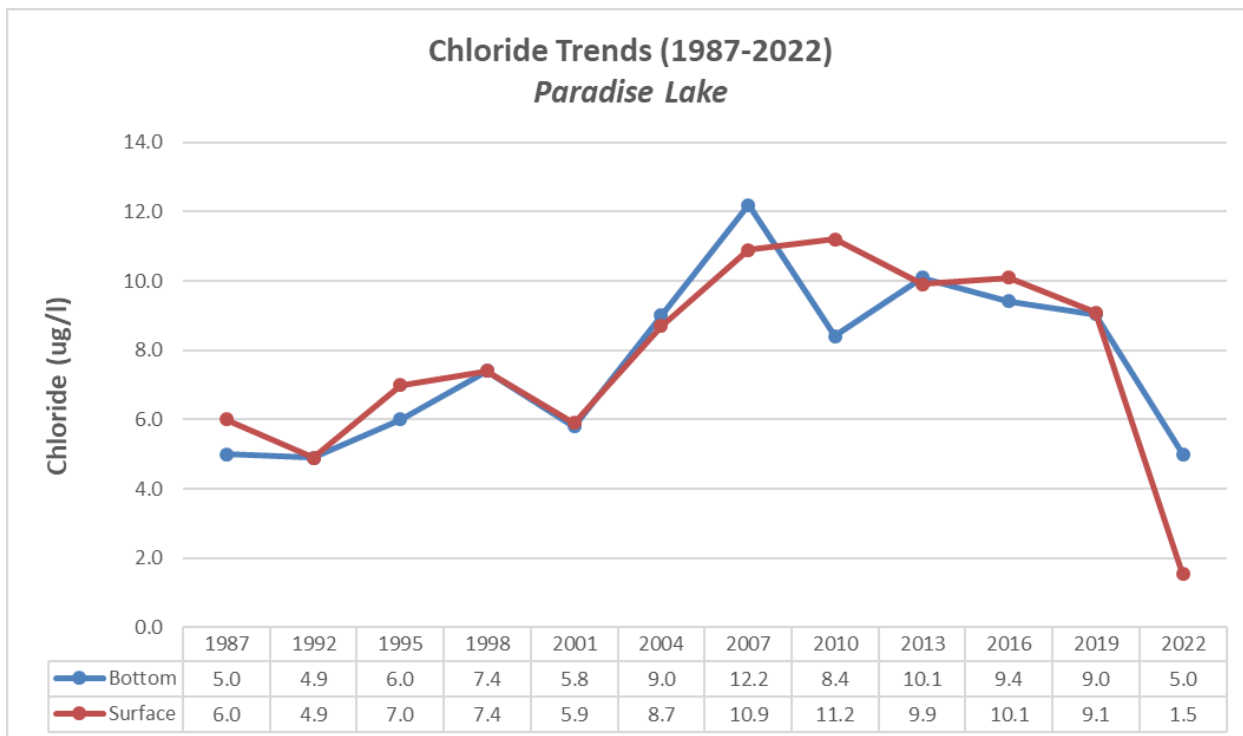
Figure 4. Chloride trends in Paradise Lake, from 1987 - 2022, collected through the Comprehensive Water Quality Monitoring Program. Note: Not noted by red line as levels are nowhere near the maximum (320 mg/L).

Based on the above nutrient data, we see relatively stable phosphorus levels throughout the years of data collection in Paradise Lake. However, there are a few notable instances where phosphorus data exceeds the EPA recommended limit, both near the beginning of data collection (around 1987) and in later years (from 2013 - 2016). Interestingly, nitrogen levels on Paradise Lake show a general decline throughout the span of data collection. Levels consistently breached the EPA recommended maximum until around 2016. Chloride readings show no concrete trend from 1987 – 2022 and levels do not approach the recommended maximum. Conductivity readings are within a suitable range to support healthy freshwater fish populations and do not exhibit a concrete trend throughout the span of data collection. There is a noticeable jump, however, in bottom-level conductivity in the year 2013, where levels reach almost 300 uS/cm². However, this value is well within range for a healthy freshwater ecosystem, and does not suggest anything atypical.

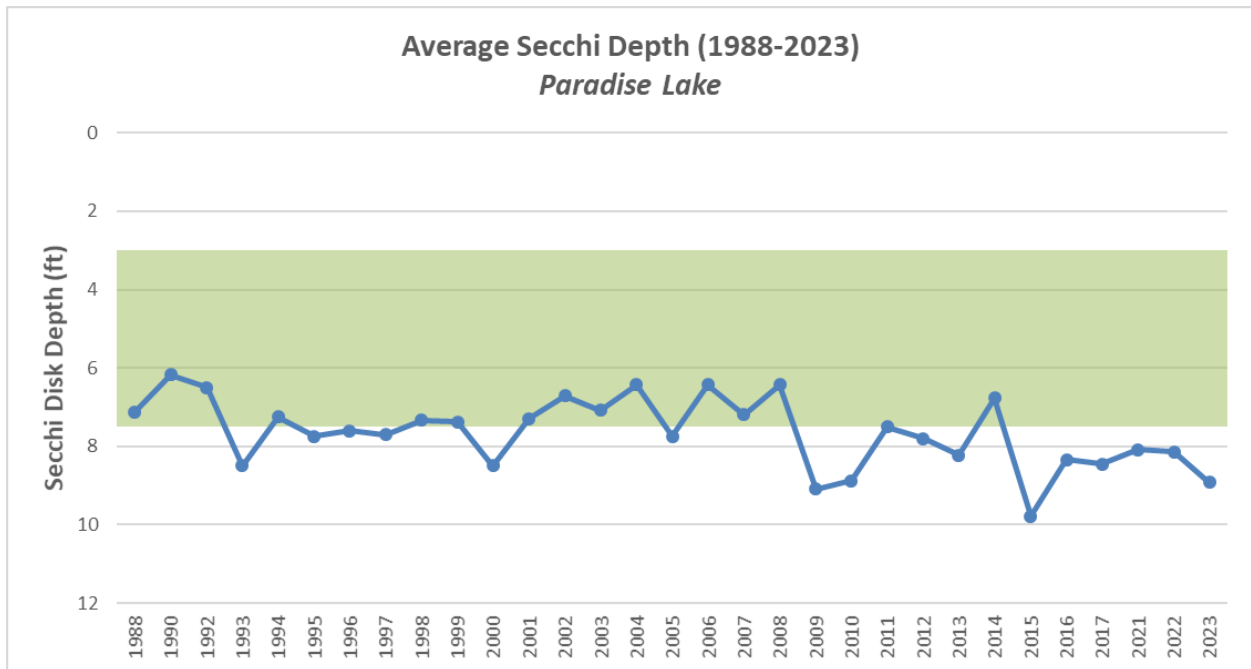
Figure 6. Secchi disk depth trends in Paradise Lake, from 1988 - 2023, collected through the Volunteer Lake Monitoring Program. Note: Green shaded region indicates a eutrophic ecosystem (Secchi depth readings of 3.0 feet to 7.5 feet). Readings less than 3.0 feet are indicative of a hypereutrophic ecosystem.

Based on the above data, we see that water clarity data collected via Secchi disk demonstrates that Paradise Lake has exhibited eutrophic conditions over time, most notably in 1990 and 2008, where

water clarity barely surpasses 6 feet. Interestingly, water clarity has increased beginning in 2015, and has remained under the eutrophic ‘threshold’ since then, with Secchi depth extending to about 8 feet. In comparison to this, chlorophyll-*a* data is not indicative of eutrophic conditions based on previous data, where levels stayed under 5 ug/L, and concentrations begins to level out around 2009 onwards. Trophic Status Index values for Paradise Lake approached eutrophic conditions (maximum TSI value of 46), but do not reach 48 (TSI reference point for eutrophication).

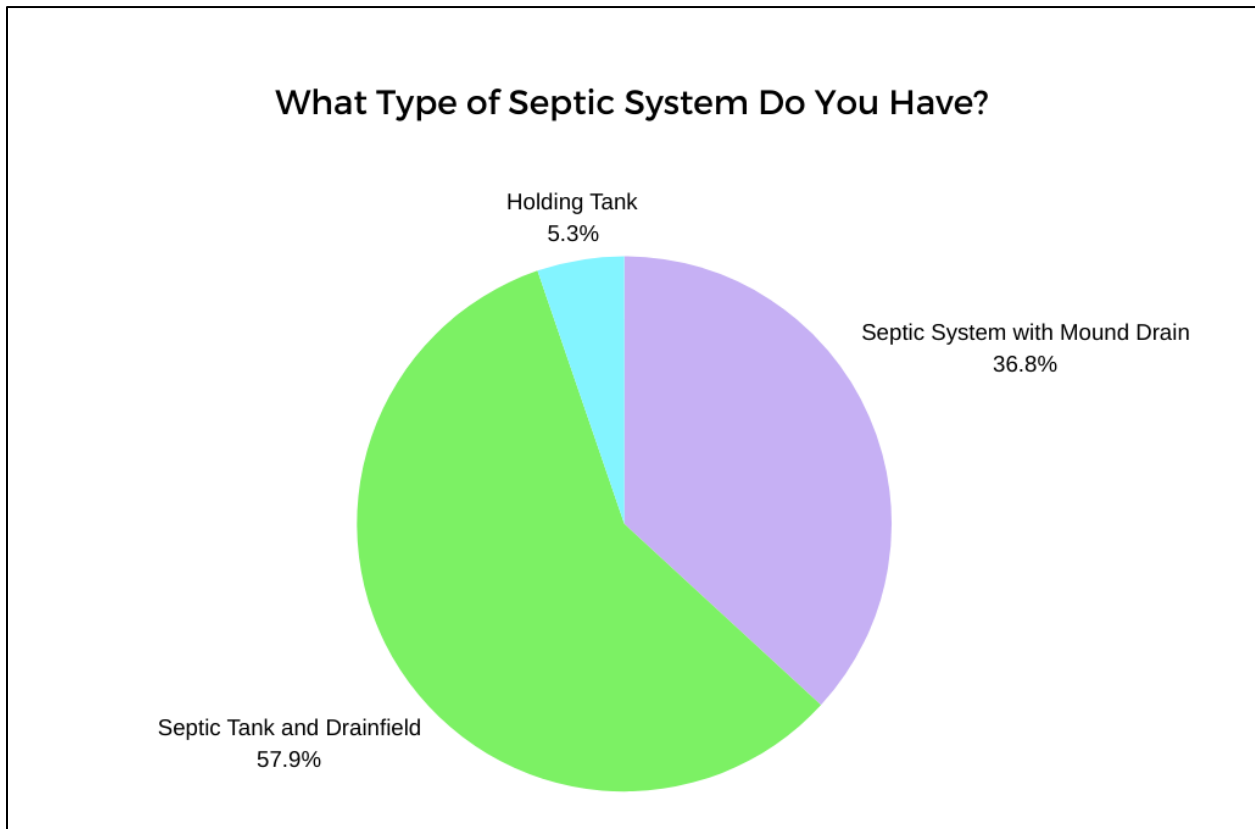
Figure 11. Types of septic systems on lakefront properties for Paradise Lake. A septic tank with an accompanying drainfield is what the majority of homeowners utilize.

Lakefront property owners were first asked what type of septic system they had (Figure 11). They were also asked about the dimensions of the tank (in gallons). 5 respondents indicated that the tanks were 1000 gallons, 2 had tanks above 1000 gallons, and 2 indicated a 500 gallon tank. 10 of the respondents either stated they did not know the dimensions of the tank, or did not provide usable data.

The majority of respondents (57.9%) indicated that they have a septic system with an accompanying drainfield, with septic systems with a mound drain being the second-most common type of system (36.8%, Figure 11). Unfortunately, tank failure and drainfield failure were cited by some respondents as problems they experienced with their system(s). Failing septic tanks or drainfields present with sewage backup, standing water or lush grasses over the drainfield, lakefront algal blooms, or bacterial contamination of recreational waters (United States Environmental Protection Agency). In fact, the Paradise Lake Shoreline Survey (2002) states that many *Cladophora* blooms were associated with fertilized lawns and/or septic system drainfields.

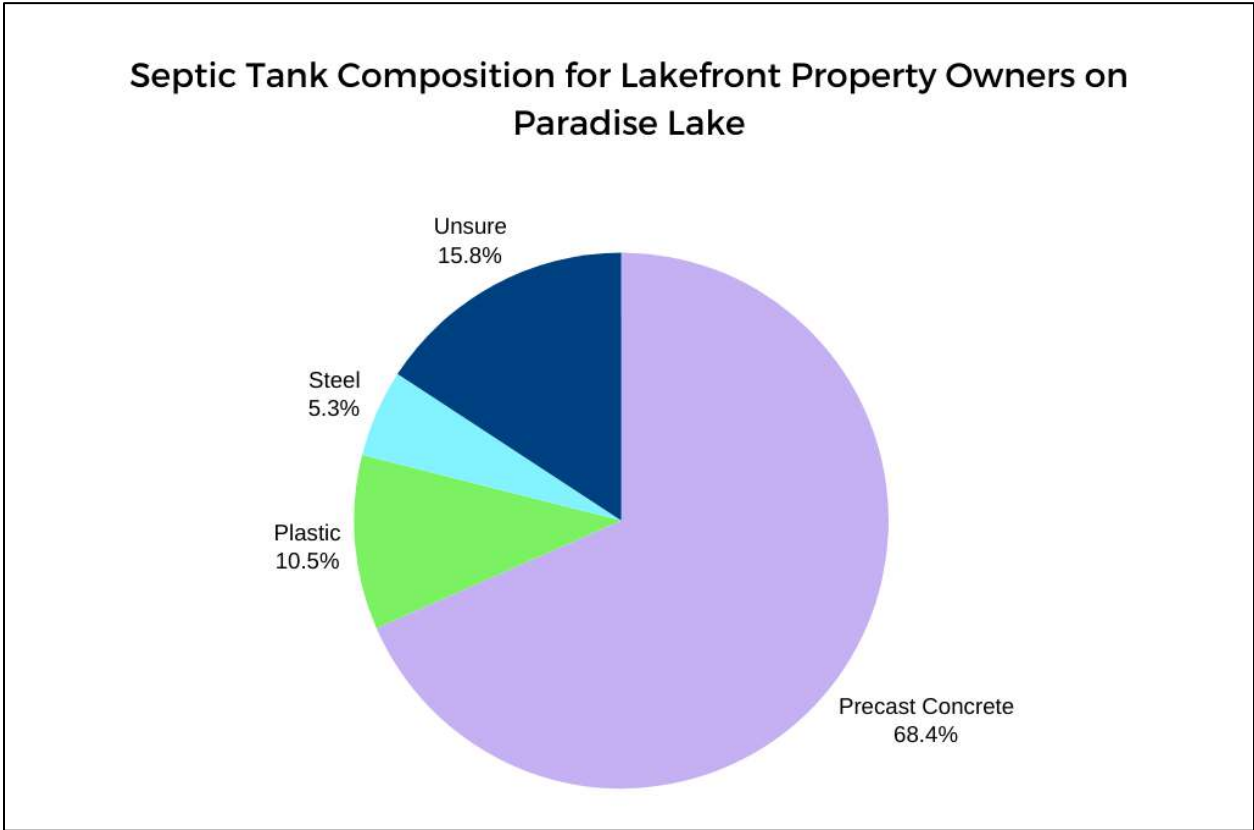
Figure 12. Various septic tank compositions for lakefront property owners. Precast concrete is the most common material.

The majority of respondents indicated that their septic systems were made out of precast concrete (Figure 12), with 74% of residents pumping/planning to pump their septic tanks every 3-5 years. This is the recommended pumping schedule and increases the longevity of the system. Though only a small portion of respondents (16%) confirmed that they had experienced issues with their systems, both tank and drainfield failure were recorded, which, if left untreated, can lead to a plethora of water quality issues. Fortunately, many of the respondents described their septic tank as further than 100 feet from the lake, lowering the chances of effluent reaching the surface water.

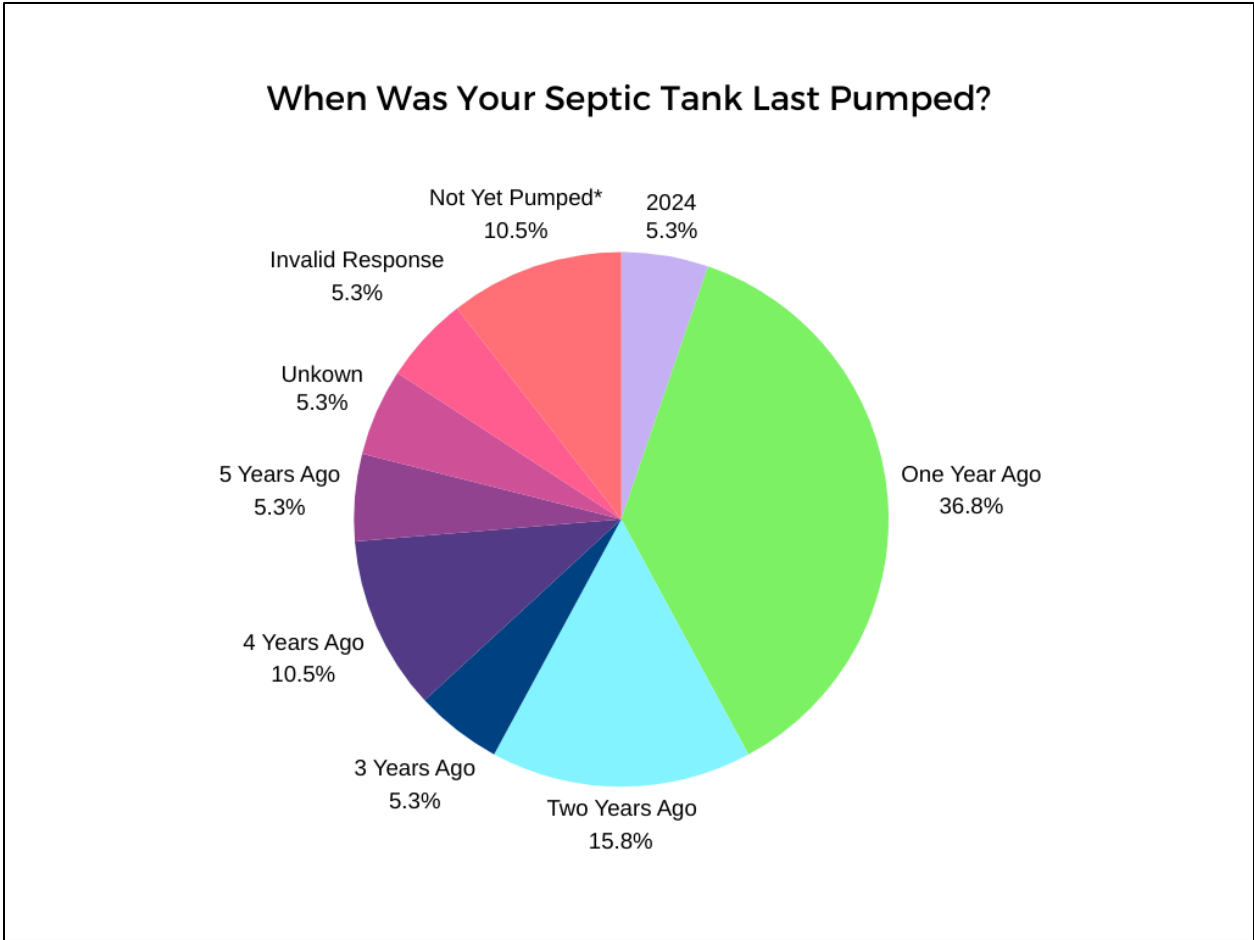
Figure 13. Categories (by years) for when respondents' septic tanks were last pumped. 36.8% of septic tanks were pumped in 2023. *10.5% of respondents indicated their septic tanks had not yet undergone routine pumping due to a new tank recently being installed, or the occupancy being low to the point that the tank was not in use.

Finally, respondents were asked how many bathrooms were in the household, how old their septic system was, and when the tank was last pumped. Number of bathrooms ranged from 1-4, with 1 bathroom and 3 bathrooms as the most typical options. Septic system ages ranged from 3 years old to 60+ years of age, with 58% of septic systems being 25+ years old. Septic tank previous pumping ranged from as early as this year (2024) to 5 years ago, with some respondents saying that they were unsure/the information was unknown (Figure 13).

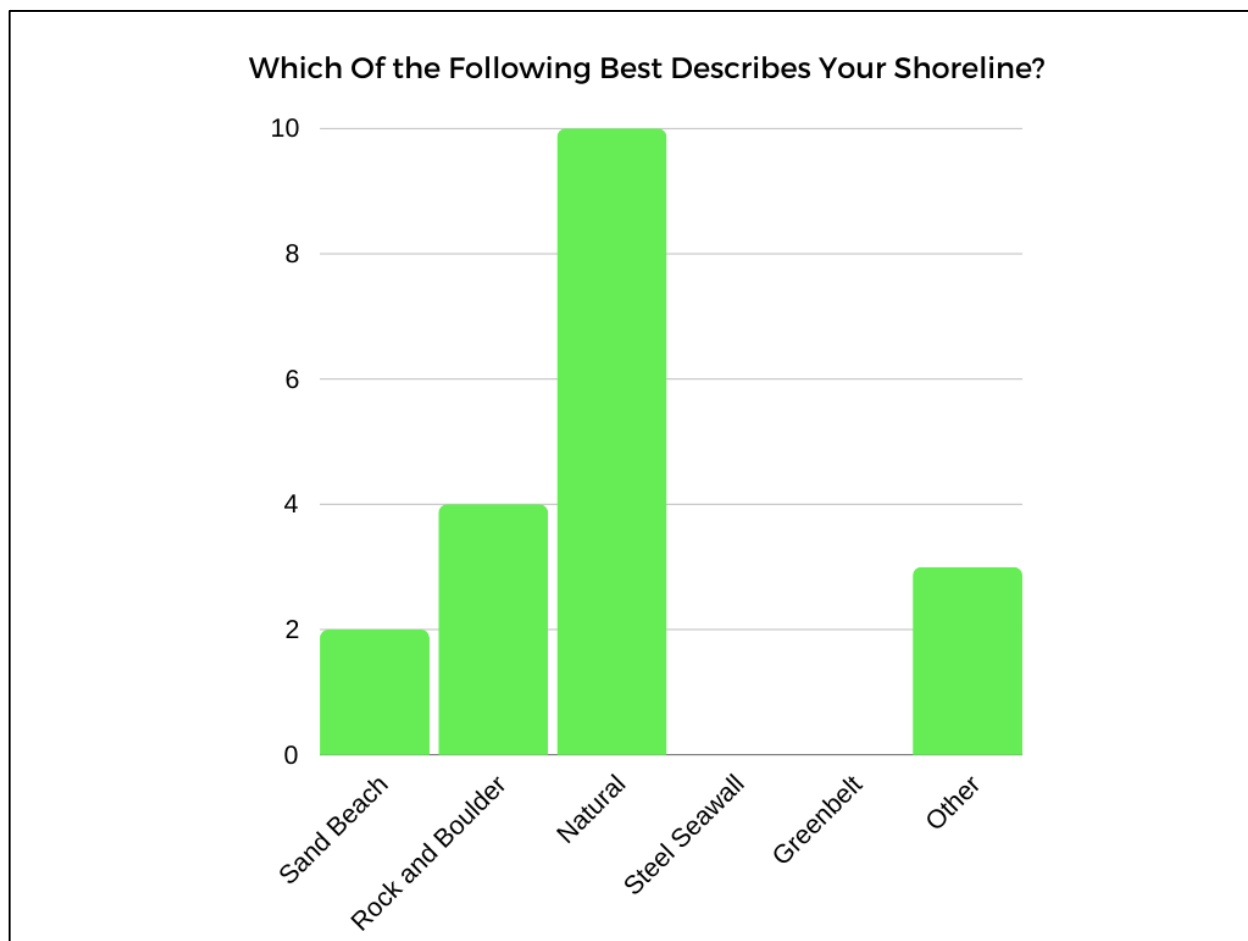
Figure 14. Characterization of shorelines on Paradise Lake. The most common shoreline type was 'natural', indicating that little to no disturbances or changes had occurred.

Respondents were asked to characterize their shoreline (Figure 14). If their shoreline did not fit within one of the provided categories, they provided their own explanation and selected 'other'.

While the majority of respondents selected 'natural' as their shoreline type, many respondents (>3, as shown in the above graph) chose to describe their shoreline as 'other'. For example, respondents included descriptions such as 'concrete seawall with rip-rap', 'mix of rocks and vegetation', and a few respondents that listed a mixture of sand, rocks, and vegetation.

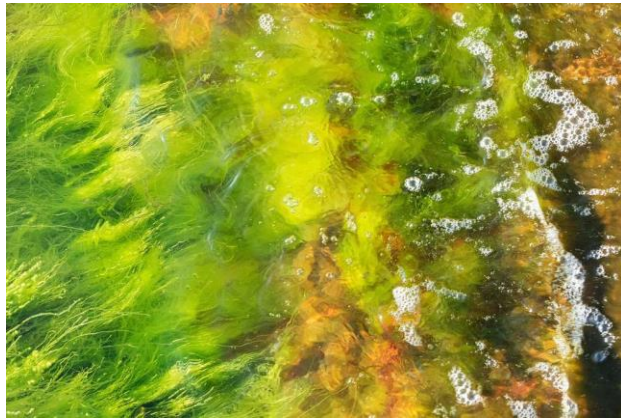
proliferates in response to excess nutrient concentrations (Image 1). While not harmful to human health, *Cladophora* can clog pipes, interfere with boating and recreation, decay and produce rotting masses, and is generally unsightly.

Image 1. *Cladophora*, a green, filamentous algae.

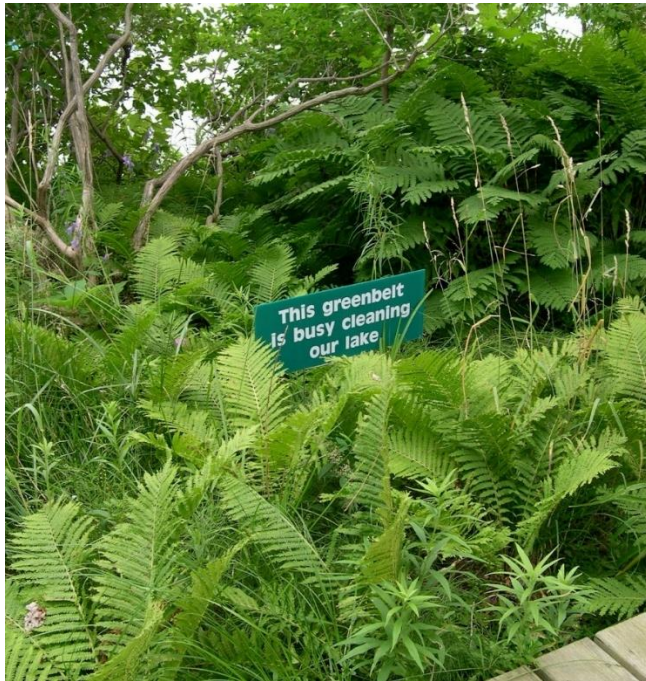
Image 3. A greenbelt in action. Greenbelts prevent erosion and uptake/filter nutrients.

While responses demonstrated that erosion and algal growth were quite low, fertilizer use was limited, and that any aquatic plants present were not increasing in abundance, only 32% of respondents stated that they have a greenbelt (a strip of native vegetation consisting of shrubs, bushes, trees, and native plants) with a depth of 50+ feet. However, the most popular shoreline characterization was 'natural', indicating that many property owners likely have a built-in greenbelt due to the lack of alterations made to the property. Greenbelts stabilize shorelines, prevent erosion, filter excess sediment and nutrients before they can reach the lake, and provide wildlife and pollinator habitat (Image 1). Greenbelt installation is a recommended way
