Crooked and Pickerel Lakes: 2024 Shoreline Survey

October 25th 2024

Tip of the Mitt Watershed Council

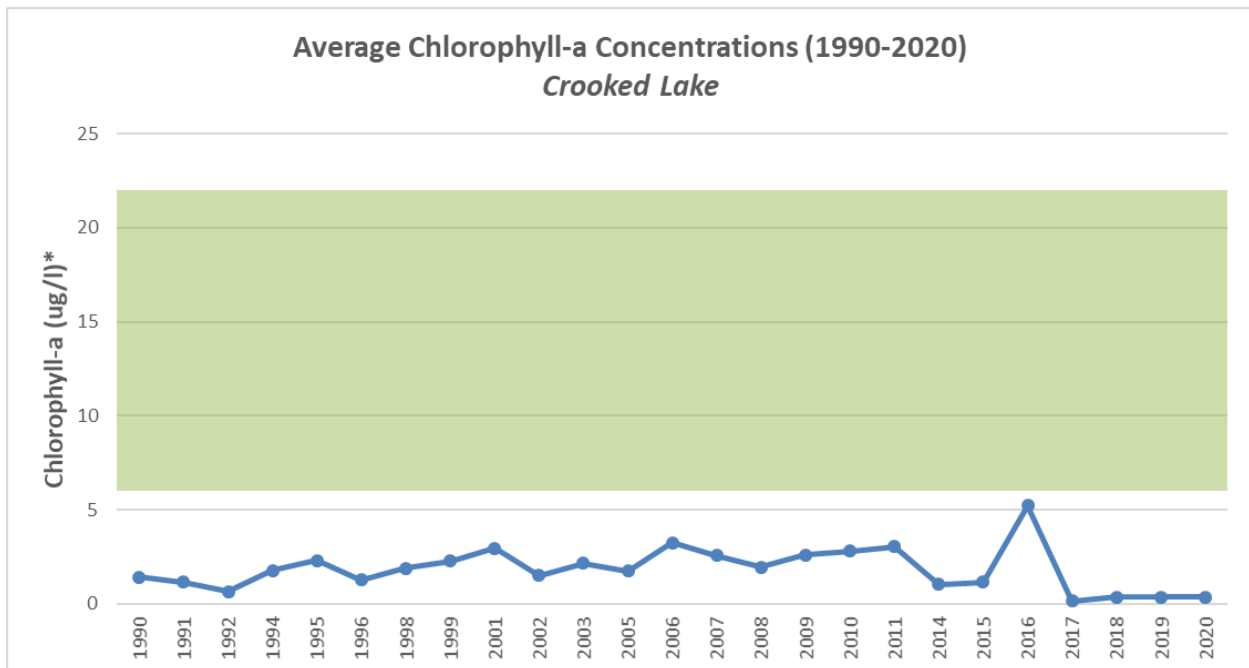
Figure 12. Chlorophyll-a trends in Crooked Lake, from 1990 - 2020, collected through the Volunteer Lake Monitoring Program. Note: Eutrophic conditions are indicative of chlorophyll-a concentrations at 6.0 ug/L and above (green shaded region). Levels do not exceed this threshold for this lake in the data reflected above.

Regarding Secchi depth data on Crooked Lake, water clarity was low enough to reflect eutrophic conditions in Crooked Lake in the late 1980s and throughout the 1990s. Chlorophyll-*a* concentrations exhibited a notable spike in 2016, reaching almost 6.0 ug/L, but did not cross this threshold. Conditions were not eutrophic according to chlorophyll-*a* data. TSI values have approached 50, indicating eutrophic conditions in the lake. In more recent years, levels have dropped (2019 onwards), showing that nutrient influx may be decreasing in Crooked Lake.
